BRADCO Service Bulletin

The Power of Combined Excellence

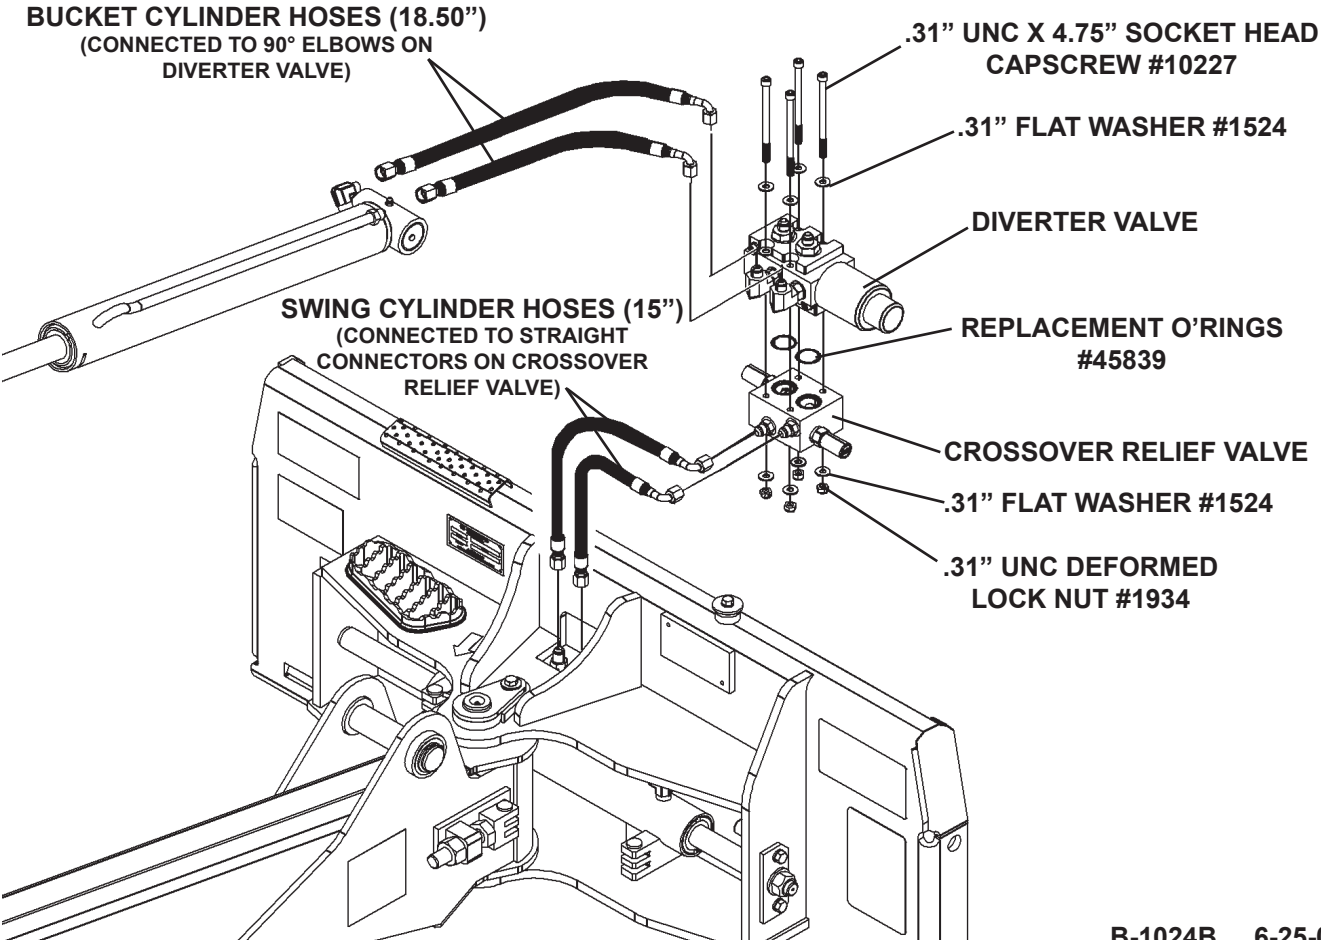
See the diagram below to verify hose routings to the bucket cylinder and to the bulkhead fittings going to the swing cylinder. These hoses are not interchangeable due to the hose length. If these hoses are switched around on your unit, please reroute as shown to prevent hose damage and to achieve the desired operating function of swing left and dump.

There has been an update to the BRADCO Skid Steer Loader Swing Hoe. Due to reports of external leaking of the valves on the swing hoe the hardware connecting the valves has been changed to four .31" UNC X 4.75" Socket Head Capscrews, eight flat washers and four deformed lock nuts. **NOTE: When replacing your existing .25" hardware check o'rings between valves for damage and replace if necessary.**
